May 27 Milton SS 3 Phase Fault Incident Report

Report to NPCC

Document ID	IESO_REP_0272
Document Name	Milton Fault and Voltage Excursion May 27, 2005
Issue	
Effective Date	July 6, 2005

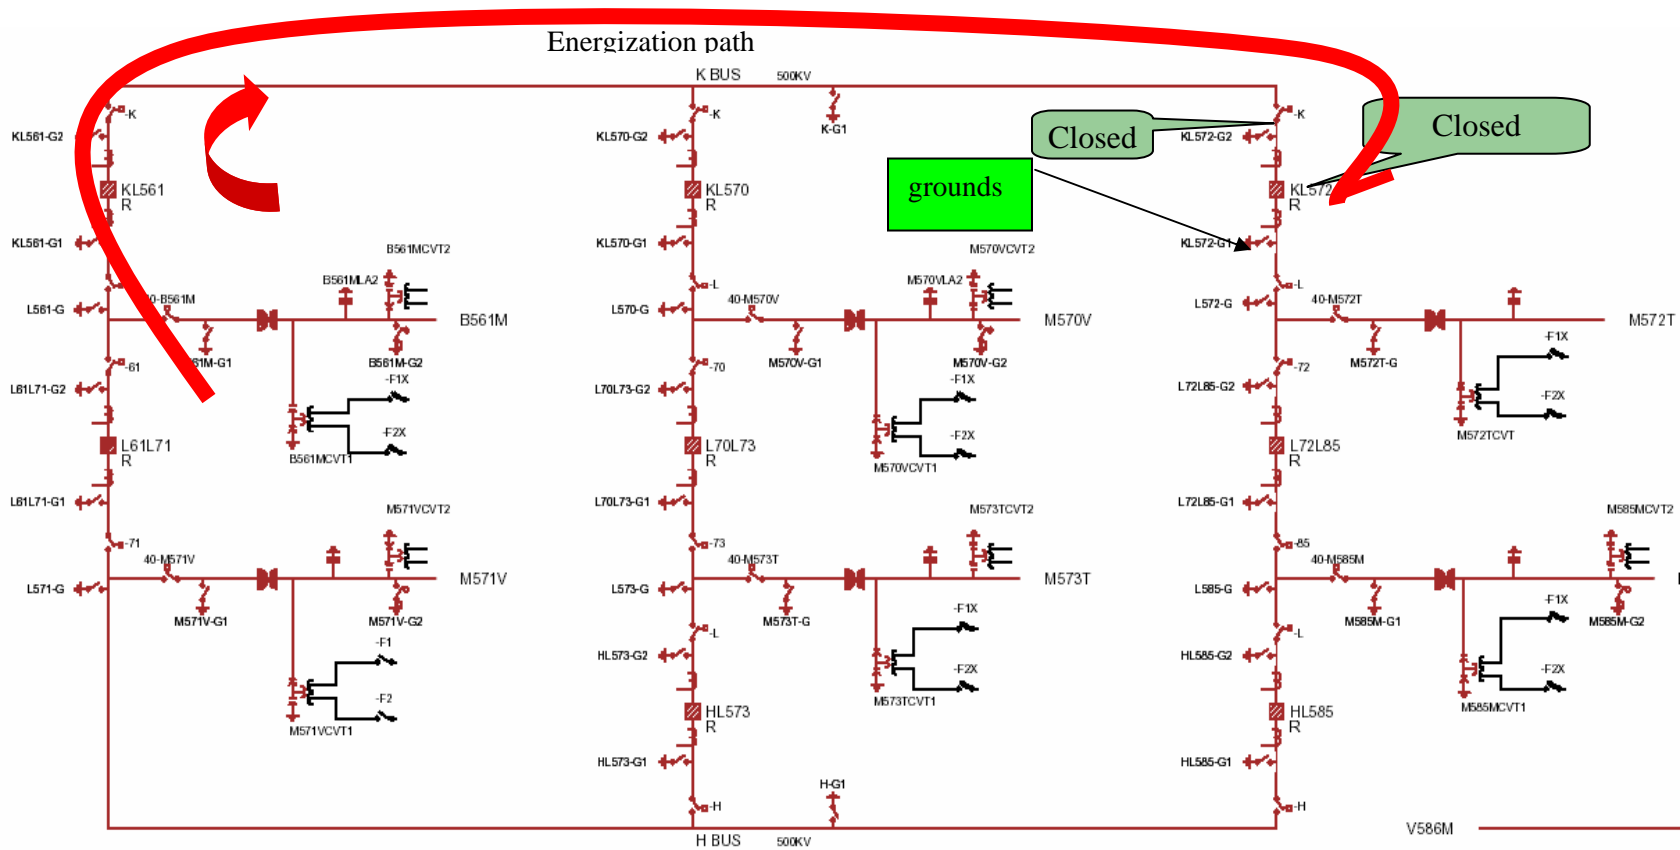
Figure 1: Bus Configuration at Milton SS

An overview of the Milton Station is illustrated in Figure 1. Prior to the event, the Milton K bus was out of service to provide safety clearances for crews working in the station. Crews were performing tests on the KL572 breaker which was undergoing a major planned overhaul. Upon completion of the test, the K bus was to return to service while KL572 breaker was to remain out of service for further planned work.

At 15:15 EST, without confirming the position of the KL572 breaker and its disconnect KL572-K, the transmitters' operator proceeded to close the KL561 breaker energizing the K bus and the KL572 breaker up to the KL572-L disconnect. A three phase to ground fault was produced through the KL572-G1 ground switch that is located between the KL572 breaker and the KL572-L disconnect. The Milton M572T terminal correctly tripped from its own line protection in 55 ms. However, the fault was still being fed through the KL561 breaker³. The KL572 breaker failure protection ultimately tripped the KL561 and interrupted the fault in 156 ms. Protection operations led to the tripping of circuits M572T, M573T and M570V. As well at 15:15:30 EST there was an emergency shutdown of a small 50 MW co-generator.

³ The KL572 breaker was left in the test position and the 62a timer path disabled due to the pallet switch assembly being removed for breaker maintenance with the advanced breaker position auxiliary contact (aa) in the open position.

The tripping of circuit M572T was expected as the fault was within range of the zone 1 relays at Milton. The M570V and M573T trips were unexpected and conflicted with the fault's location. Initial investigations by an independent consultant have recommended that the "apparent" impedances, observed by remote terminal protections during the fault conditions, be assessed further to help rationalize the protection operations observed and to enable Hydro One to determine the mitigating actions required to prevent the over tripping of these circuits. Investigations are continuing.

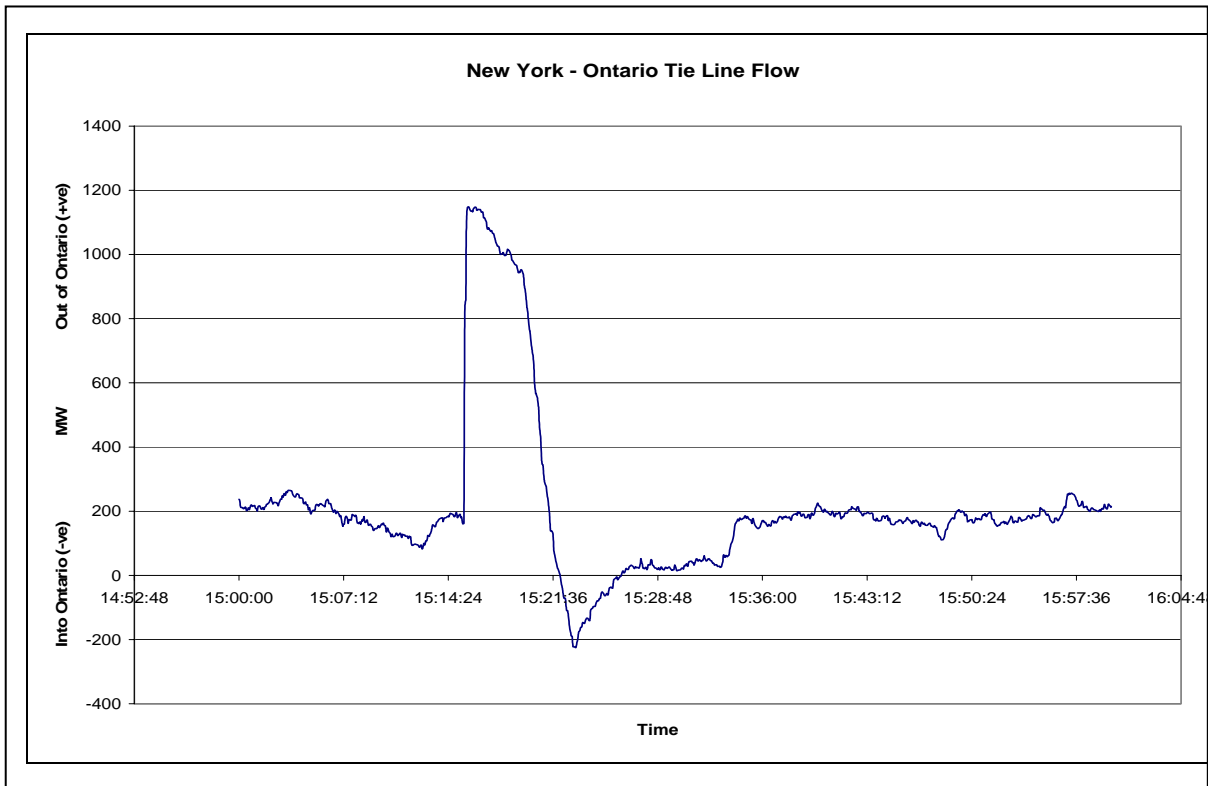
Figure 2: New York-Ontario Tie Line Flow

Immediately following the incident and as direct consequence of the load loss in Ontario, flows on the Michigan & New York interfaces increased by 1000 MW and 980 MW respectively and stabilized at approximately 820 MW and 1180 MW respectively, well within the interties' continuous rating.

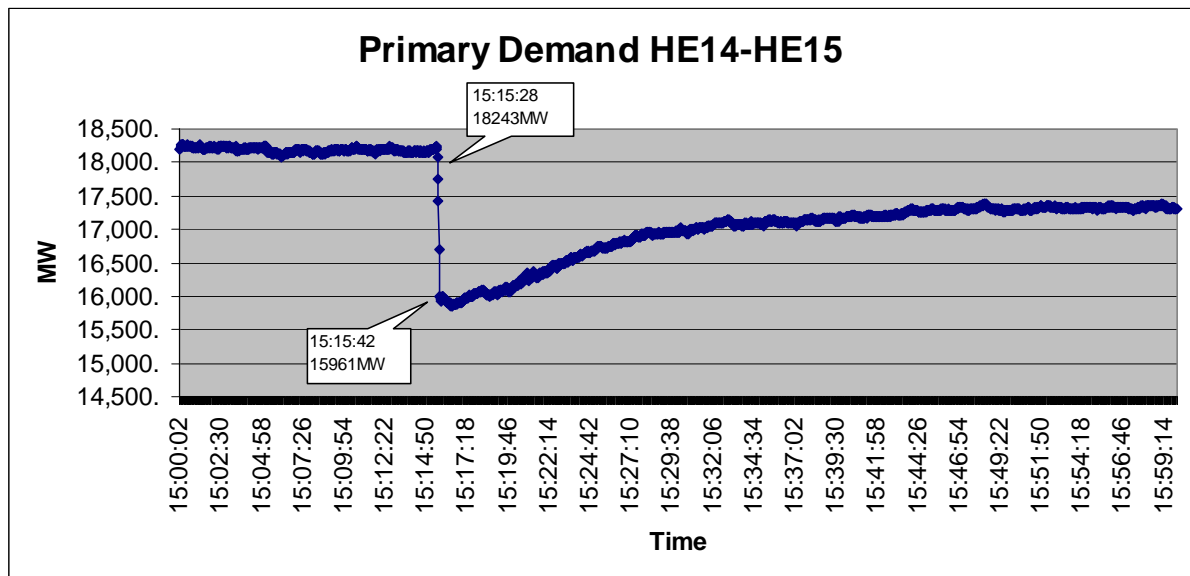
Figure 4: Ontario Primary Demand

Approximately 2300MW of load was isolated from the Ontario grid due to the fault at Milton. A sharp drop was observed in Ontario Demand, which was approximately 18,250 MW pre-fault and fell to approximately 15,950 MW post contingency.

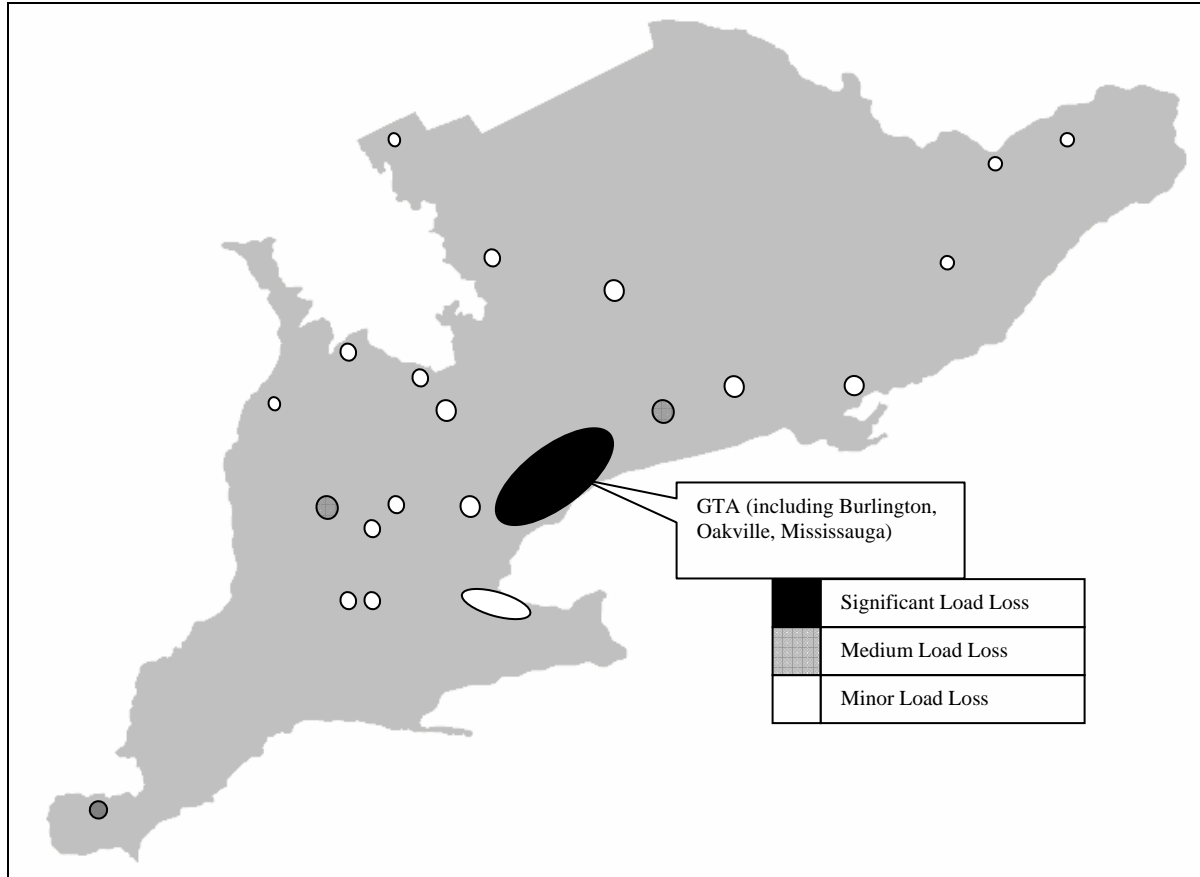
Figure 5: Approximate Extent of Load Loss During Milton Event

Metering data for declining loads at the time of the fault showed the physical scope of the load loss to be fairly widespread. However, a larger concentration of affected loads was centered in the Greater Toronto Area, specifically in the Milton, Claireville and Richview regions.

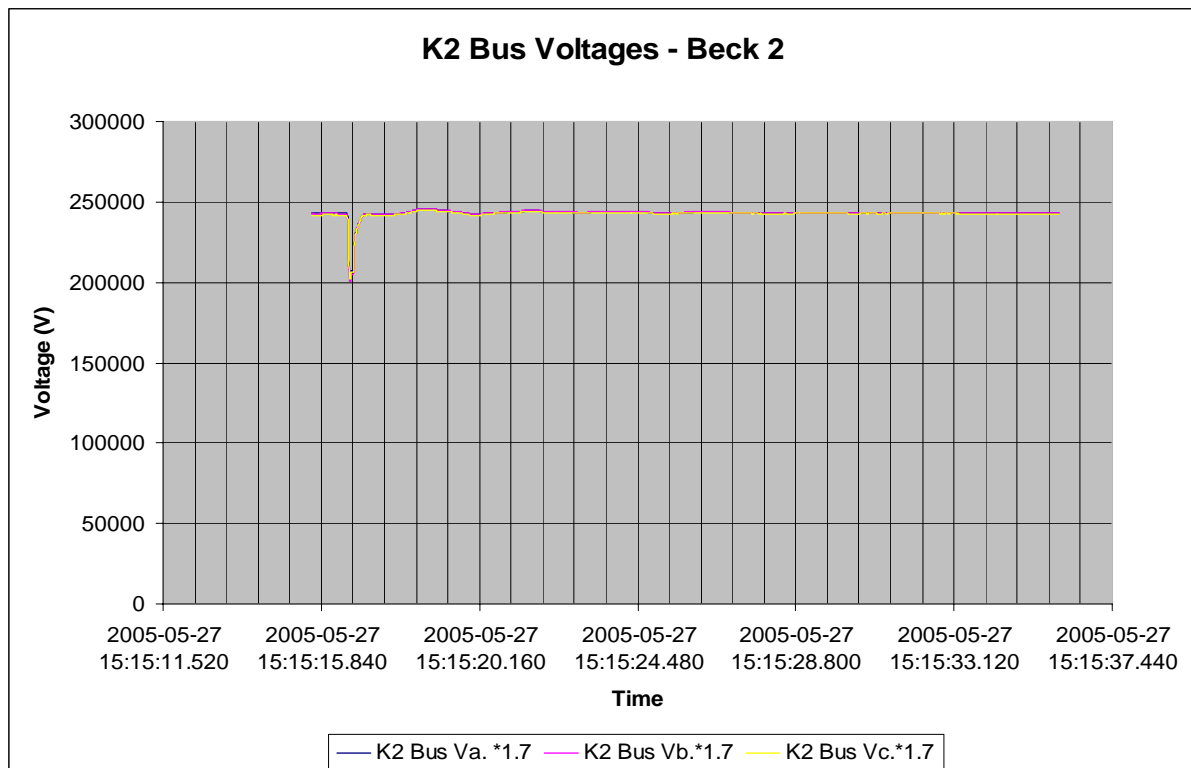
Graph 1

Graph #1 illustrates the voltage profile at the Sir Adam Beck Complex on the Ontario – New York interface at Niagara. Graph #2 and 3 illustrate the voltage profiles on the Ontario – Michigan interface at the Lambton generating station in the Sarnia area and at Keith transformer station in the Windsor area respectively.

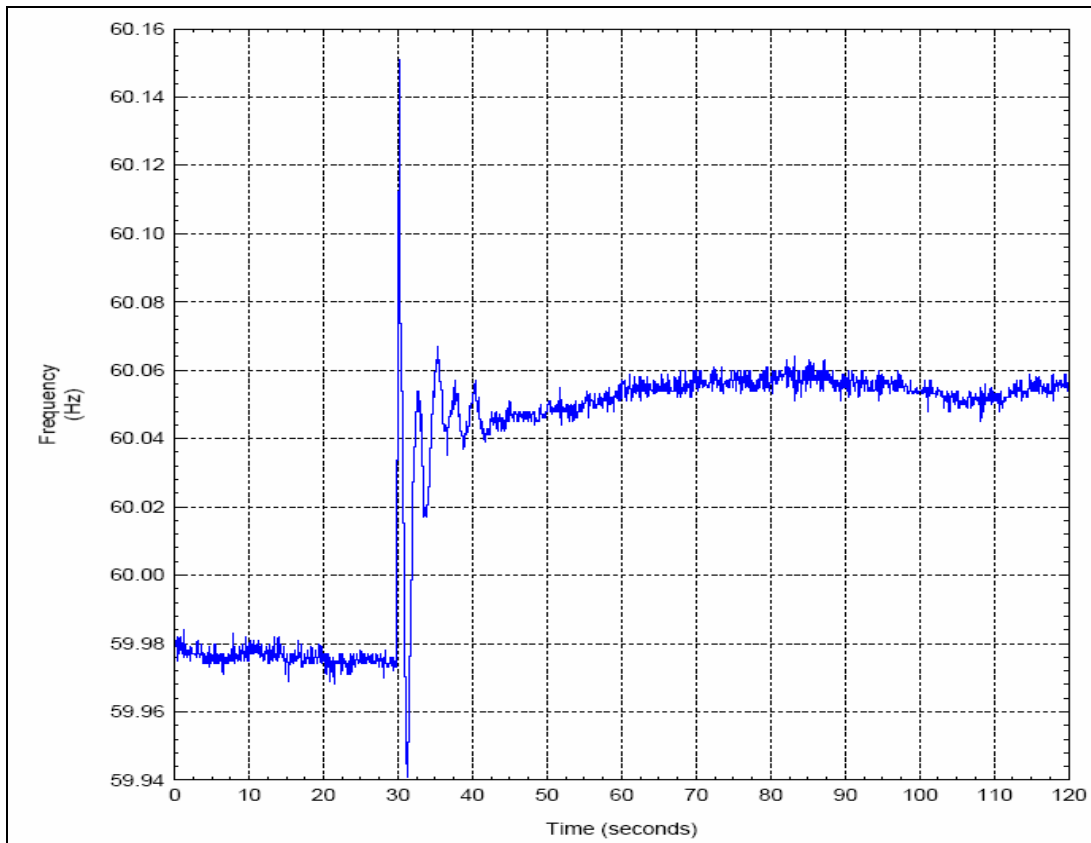
Figure 6: Frequency

Frequency fluctuations resulting from the fault were experienced throughout the Interconnection. From the graph⁴ below, the range of the deviation extended from roughly 59.94 hertz to 60.16 hertz. These swings are well damped as can be seen in the graph and subsided within approximately 15 seconds.
