MV-90 Meter Communications Issues and Best Practices

Revenue Metering Sub-Committee Meeting

March 8, 2006

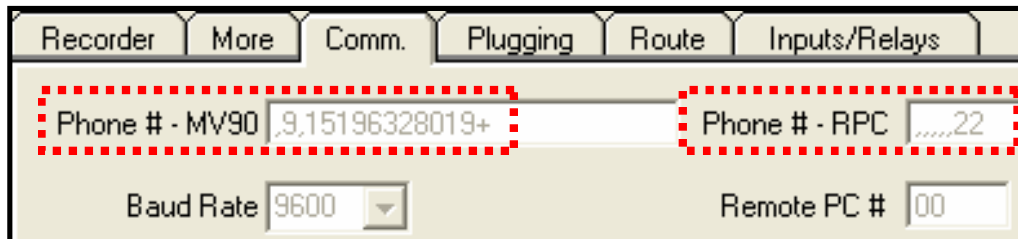
New Two Field Telephone Number Formatting Standard in MV-90

- q Adoption of new two field formatting standard for storing telephone numbers in MV-90 master files

Phone # - MV90 .9,15196328019+ Phone # - RPC22

Local Phone No. .9,15196328019+

- q In conjunction with the introduction of the leading “,9,” sequence, we have reformatted our MV-90 data base as follows:

- ü “Phone # - MV90” field (“**Local Phone No.**” field in MIRT tool)
 - stores only the characters required to acquire dial tone and the base public telephone number (including long distance character(s) where required) and the “+” symbol where needed to instruct MV-90 to take the balance of the dial string from the “Phone# - RPC field”
- ü “Phone # - RPC” field (“**Remote Phone No.**” field in MIRT tool)
 - stores all characters used to control call transfers via either automated telephone attendants, telephone line sharing devices, etc.

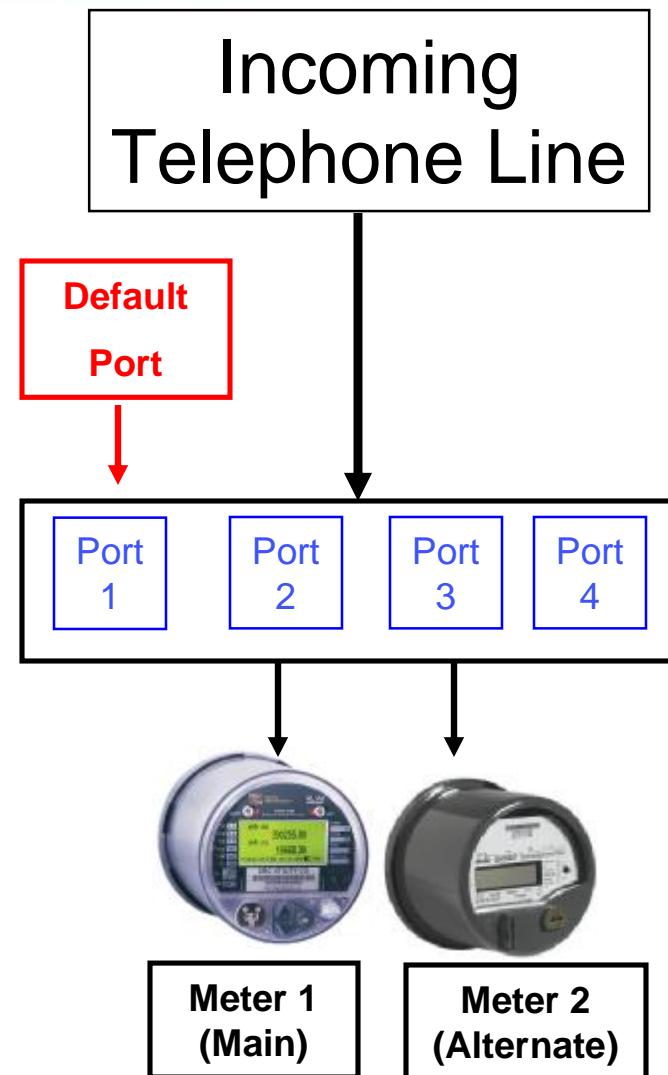
Known Issues with Telephone Line Sharing Devices (2)

- q Expect Ring Signal **“Leakage”**
- Most models will leak some ring signal to one or more unintended ports during a call transfer – “Chirp” phenomena
 - **DO NOT** program the meter’s modem to answer on the first ring (typically the meter manufacturer’s default setting)
 - Program the meter’s modem to answer **AFTER 3 rings**
 - ü Prevents unintended “wake up” of the wrong modem/meter during initial “Chirp” of leaked ring signal
 - Most meter vendors allow you to modify the internal modem’s answer ring delay without breaking the seal

- q Devices connected to “Voice 1” and “Voice 2” will experience “Chirp” when incoming calls are answered by “The Stick”
- q This may cause sensitive modems to initiate answer attempt and create an MV-90 **“Hello Wrong Meter”** Error Return code

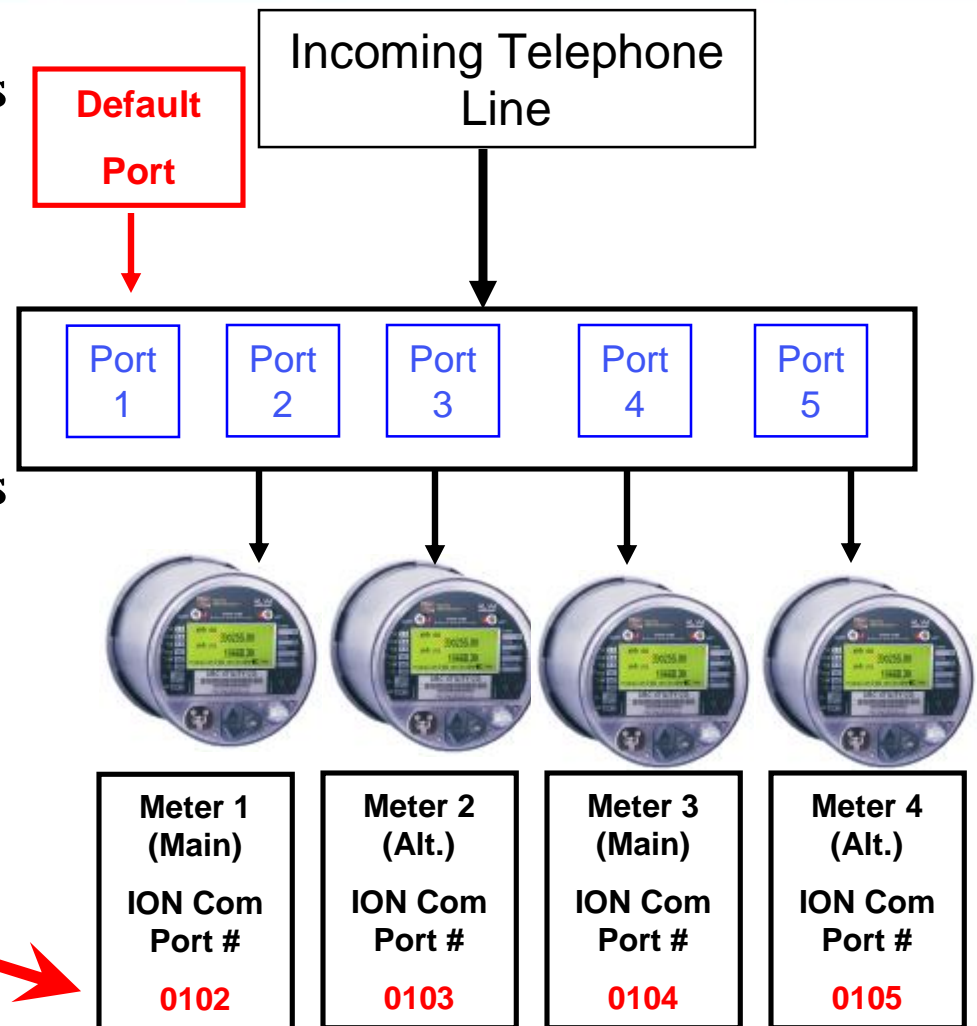
Known Issues with Telephone Line Sharing Devices and ION Meters

- q MV-90 Communicates with a ***SPECIFIC*** ION Com Port Address Number rather than the Device ID (TAG2) field !!!
- q Each MV-90 Call **must** match the right most 4 characters of the Recorder Master File's "Phone Password 2" field with the ***SPECIFIC*** ION Com Port Address Number on the answering ION meter
- q Recommendations:

- Ensure multiple ION meters connected to the same telephone line sharing device have:

- ü **Unique** ION Comm Port address numbers – default = "0101"
- ü **Unique** Password 1 field entries
